ENGINEERING EVALUATION OF AGE LIFE EXTENSION, T-10 TROOP MAIN PARACHUTE

TECHNICAL REPORT 74-46-CE

March 1974

U. S. ARMY NATICK LABORATORIES
Natick, Massachusetts

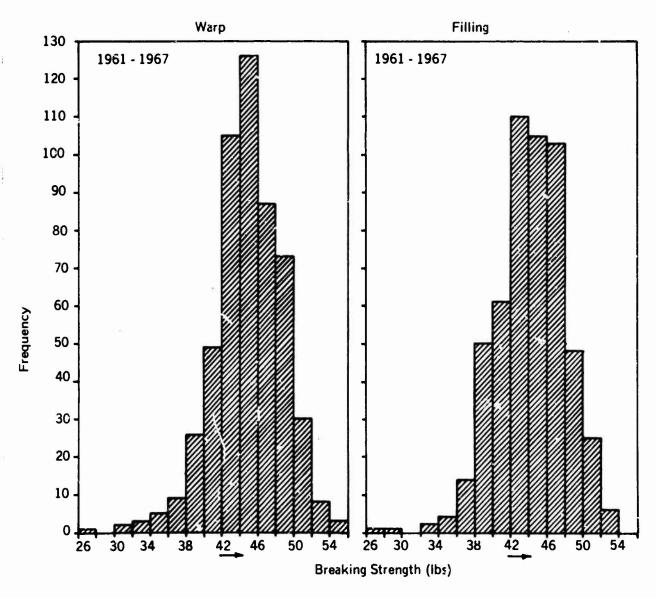
CHART 2. BREAKING STRENGTH HISTOGRAMS OF T-10 MAIN CANOPY FABRIC IN PARACHUTES MANUFACTURED IN 1961 - 1967.

A. <u>Canopy Fabric</u> — The warp and filling tensile strength data obtained on the T-10 main canopy fabric are presented by year classes in Chart 1, and collectively in Chart 2. Elongations are presented in the same manner in Charts 3 and 4, and tear strengths in Charts 5 and 6.

Several observations and conclusions can be drawn from the data. The distribution patterns appear quite normal in the statistical sense, and can be assessed by direct examination with reasonable confidence for the immediate purposes of management consideration. Additional data analysis is being carried out for further technical background and future guidance, but it is not expected to alter the basic conclusions of the surveillance study.

From the levels and distributions of the lower strength and elongation values found in the sampling, indications are that the canopy fabrics in the present populations of T-10 main canopies present no hazard at their present ages. While some individual values are significantly below the specification minima of 42 pounds strength and 20% elongation, these represent only local areas and not any canopy as a whole. In fact, more detailed examination of the basic data shows no particular within-canopy grouping of low values, and only a slight occasional association of low values for locations at the bottom and near the apex. It is thus concluded that any hazard lies in the possibility of local failure in a minor area rather than of a massive failure throughout a major area or whole canopy. This view is consistent with the findings of the previous studies of reserve parachute equipment, further indicating that the nature of the problem is primarily one of the cumulative incidence of local influences and specific effects rather than general deterioration of nylon as a class.

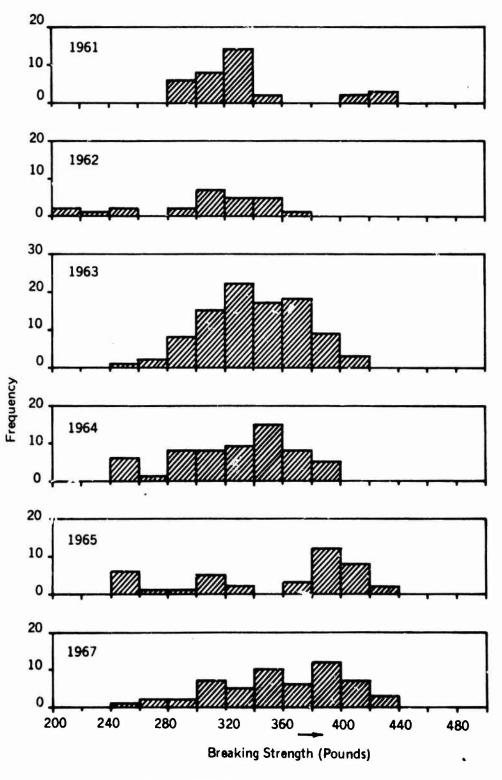
CHART 7. BREAKING STRENGTH HISTOGRAMS OF T-10 MAIN SUSPENSION LINES BY AGE CLASS

B. Suspension Lines — The strength test data for the suspension lines are presented in Charts 7 and 8, and the elongation data in 9 and 10. Most of the strength values are below the specification minima of 375 pounds tensile strength and 30% elongation. This general lowering of tensile strength during service is characteristic of suspension lines. It is attributable to mechanical conditioning of the braided sheath and core structure, locally or overall, rather than to deterioration of the nylon fibers themselves. As noted in studies summarized in NLABS—schnical Report 68-45-CM¹, it occurs primarily during the initial 20 to 30 jumps; after that there is a leveling off. The normal test strength of well-used but undeteriorated line is found to be about 325 pounds, which may be taken as the basis for comparison. The test data for this sampling show a number of individual values below this level, with some as low as 200 pounds. This degree of departure from the norm is proportionally greater than for the canopy fabric, indicating the greater sensitivity of the lines to usage and exposure during service. In this sense, as well as others as noted below, the lines are to be considered the more critical of the two components.

Following the rough estimation procedure used previously in the reserve parachute study, in which the worst sample was compared with the worst known condition of unbalanced loading, the maximum recorded total load of 2340 pounds is taken from the data in Chart 15. With the maximum unbalance of loading for one side at 66.9% of the total as shown in Chart 16, and with this distributed evenly over the 15 lines per side, the worst case loading per line would be in the 104 pound range. This estimate indicates that even under this highly unlikely combination of circumstances, there is a significant reserve load capacity.

it is also recognized that in a hang-up or other malfunction where a much injuner load might be imposed on one or two lines, it would be very unlikely that the difference between the lowest value of 200 pounds and the normal 325-pound capacity for the lines so involved would make the difference between success or failure of the jump.

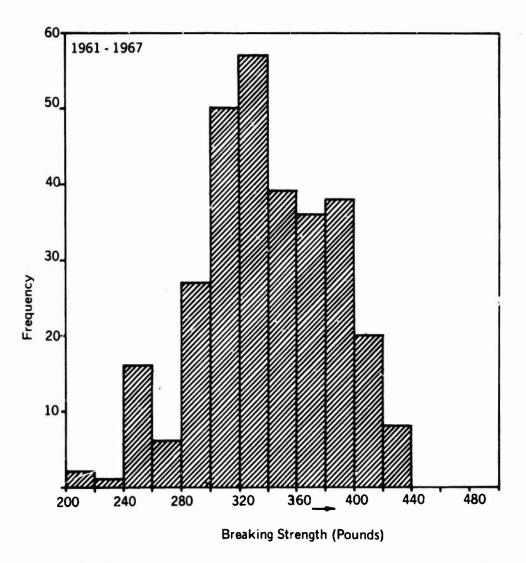
CHART 8. BREAKING STRENGTH HISTOGRAM OF T-10 MAIN SUSPENSION LINES MANUFACTURED IN 1961-1967

Unlike the situation found with the strength of the canopy fabric, the suspension lines do show a more distinct association of relatively high or low strength and elongation values within individual assemblies. Actually, most of the low values were within four or five assemblies. This grouping may reflect the characteristics of the particular lot of the original line material—its particular susceptibility to age or environmental conditions—; more probably it reflects an unusual amount or severity of exposure. Since the lines in a canopy assembly stretched on the ground or a table would probably be fairly equally exposed (unlike areas of the canopy), this repetition of characteristics within individual units is at least consistent with the concept that the condition is due to sunlight exposure in service, as perhaps from a delay in pick-up during a training exercise.

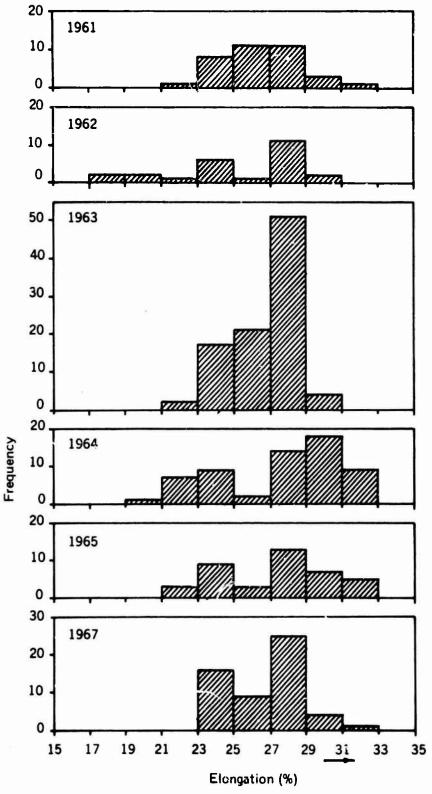
CHART 9. ELONGATION HISTOGRAMS OF T-10
MAIN SUSPENSION LINES BY AGE CLASS

The elongation data for the suspension lines similarly show a wide range, with more than a third of the values below the 30% specification minimum and also below the apparent norm of 28% for used lines. Examination showed the usual broad association of low elongations with low breaking strength. However, there were also a few instances of lower elongation, as by increased modulus or stiffening, without marked lowering of breaking strength. Such changes in stretch characteristics might affect the load distribution between adjacent lines, but not to a degree considered greatly significant for the range of values shown.

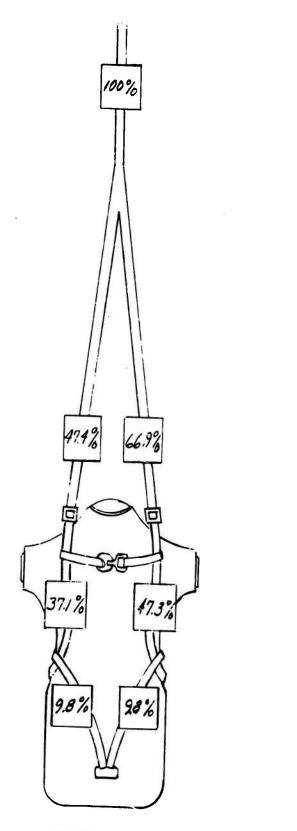
CHART. 16 Maximum Force Percentages Measured on a Parachute Harness During Canopy Opening

Assuming the maximum recorded load and distribution from Charts 15 and 16, it is conceivable as a worst condition that a leg strap might be subjected to 4160×0.28 , or 1165 pounds. However, the lowest test strength value would still indicate a two to one safety factor even in this unlikely circumstance.
